Manhole Inspection Summary

Manhole # S31S__012MH

Insp Date: **4/1/09 12:02 PM**

Location Address: **1301 Warner St**

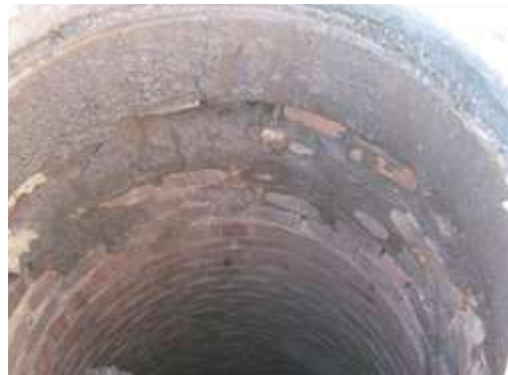
Defect 1

Frame Offset: **0** (in.) Condition: ☐ Sound ☐ Cracked ☒ **Leaks**

Frame Leaks

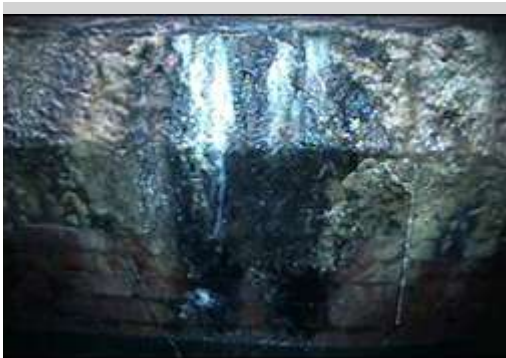
Defect 2

Infiltration: ☐ None ☐ Joint ☐ Cracks ☐ Mortar ☐ Roots ☒ **Wall**

Barrel Infiltration

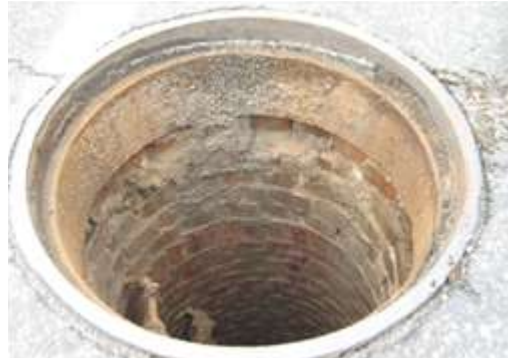
Defect 5

Condition: ☐ Sound ☐ Cracked ☐ Root Intrusion ☐ Loose Brick ☒ **Deteriorated**

deterioration in chimney

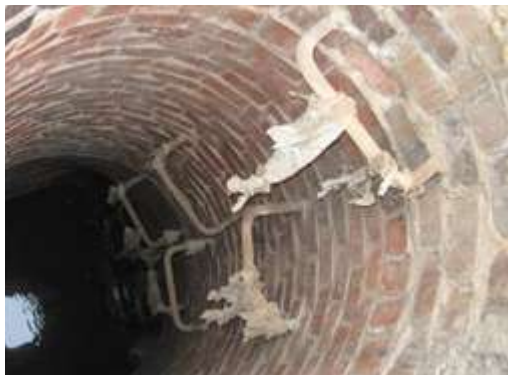
Defect 4

Steps Count: **10** Missing: **0** ☒ **Corroded**

Surcharge ☒ **Evidence Of Surcharge** Depth: **13** (ft.) ☐ Active Surcharge Present

corroded rungs
evidence of surcharge approx 13

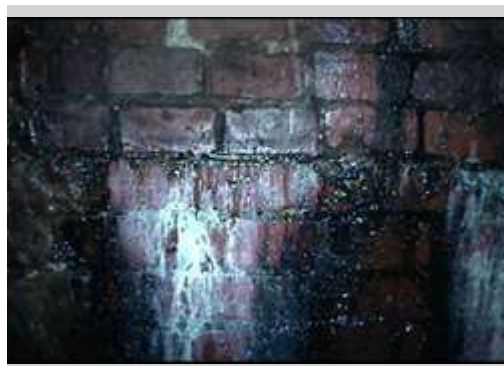
Defect 3

Infiltration: ☐ None ☐ Joint ☐ Cracks ☐ Mortar ☐ Roots ☒ **Wall**

infiltration in corbel

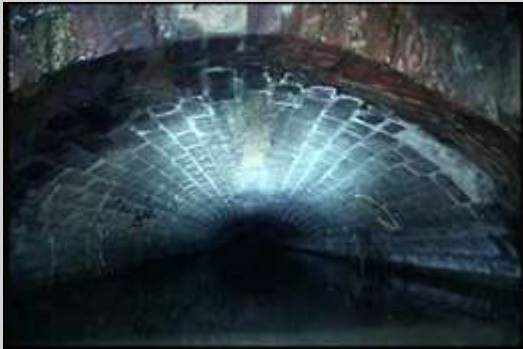
12 O'Clock Outflow

42 in. Circular Gravity Sewer
Pipe Out @ 12 O'Clock

Pipe Height: **43.2** (in.) Rod and Bar (Angled)
Pipe Material: **Clay** ☐ Pipe Lined
Invert Depth: **16.16** (ft.) Flow Characteristics: **Fast**
Deposits: ☒ None ☐ Mud ☐ Sludge ☐ Debris ☐ Grease
Silt Depth: **0** (in.) Deposits Extent:
Infiltration: **None** Pipe Seal Cond: **Sound**

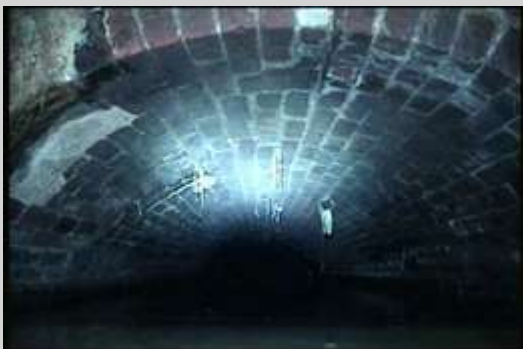
6 O'Clock Inflow

42 in. Circular Gravity Sewer
Pipe In @ 6 O'Clock

Pipe Height: **42** (in.) Rod and Bar (Angled)
Pipe Material: **Clay** ☐ Pipe Lined
Invert Depth: **16.08** (ft.) Flow Characteristics: **Fast**
Deposits: ☒ None ☐ Mud ☐ Sludge ☐ Debris ☐ Grease
Silt Depth: **0** (in.) Deposits Extent:
Infiltration: **None** Pipe Seal Cond: **Sound**
